INVESTIGATION OF LAND SUBSIDENCE AND EARTH FISSIONS IN CEDAR VALLEY, IRON COUNTY, UTAH

SPECIAL STUDY 150
UTAH GEOLOGICAL SURVEY
a division of
UTAH DEPARTMENT OF NATURAL RESOURCES
2014

In May 2009, Enoch City contacted the Utah Geological Survey (UGS) to investigate a possible “fault” that was damaging streets, sidewalks, and curbs and gutters in the Parkview subdivision in north Enoch. During a reconnaissance investigation, the UGS found a 2.5-mile-long (trace length) earth fissure that had formed in response to land subsidence that appeared to be caused by groundwater overdraft of the local aquifer. In the affected subdivision, the fissure crosses several undeveloped lots, and in addition to damaging streets and sidewalks, vertical displacement across the fissure had reversed the flow direction of a sewer line so that it is no longer possible to gravity-drain sewage from the subdivision. The likely relation of the fissure to groundwater pumping was communicated to Enoch City, the Utah Division of Water Rights, Iron County, and the Central Iron County Water Conservancy District. The UGS subsequently conducted a detailed investigation of the Enoch earth fissure, and investigated t

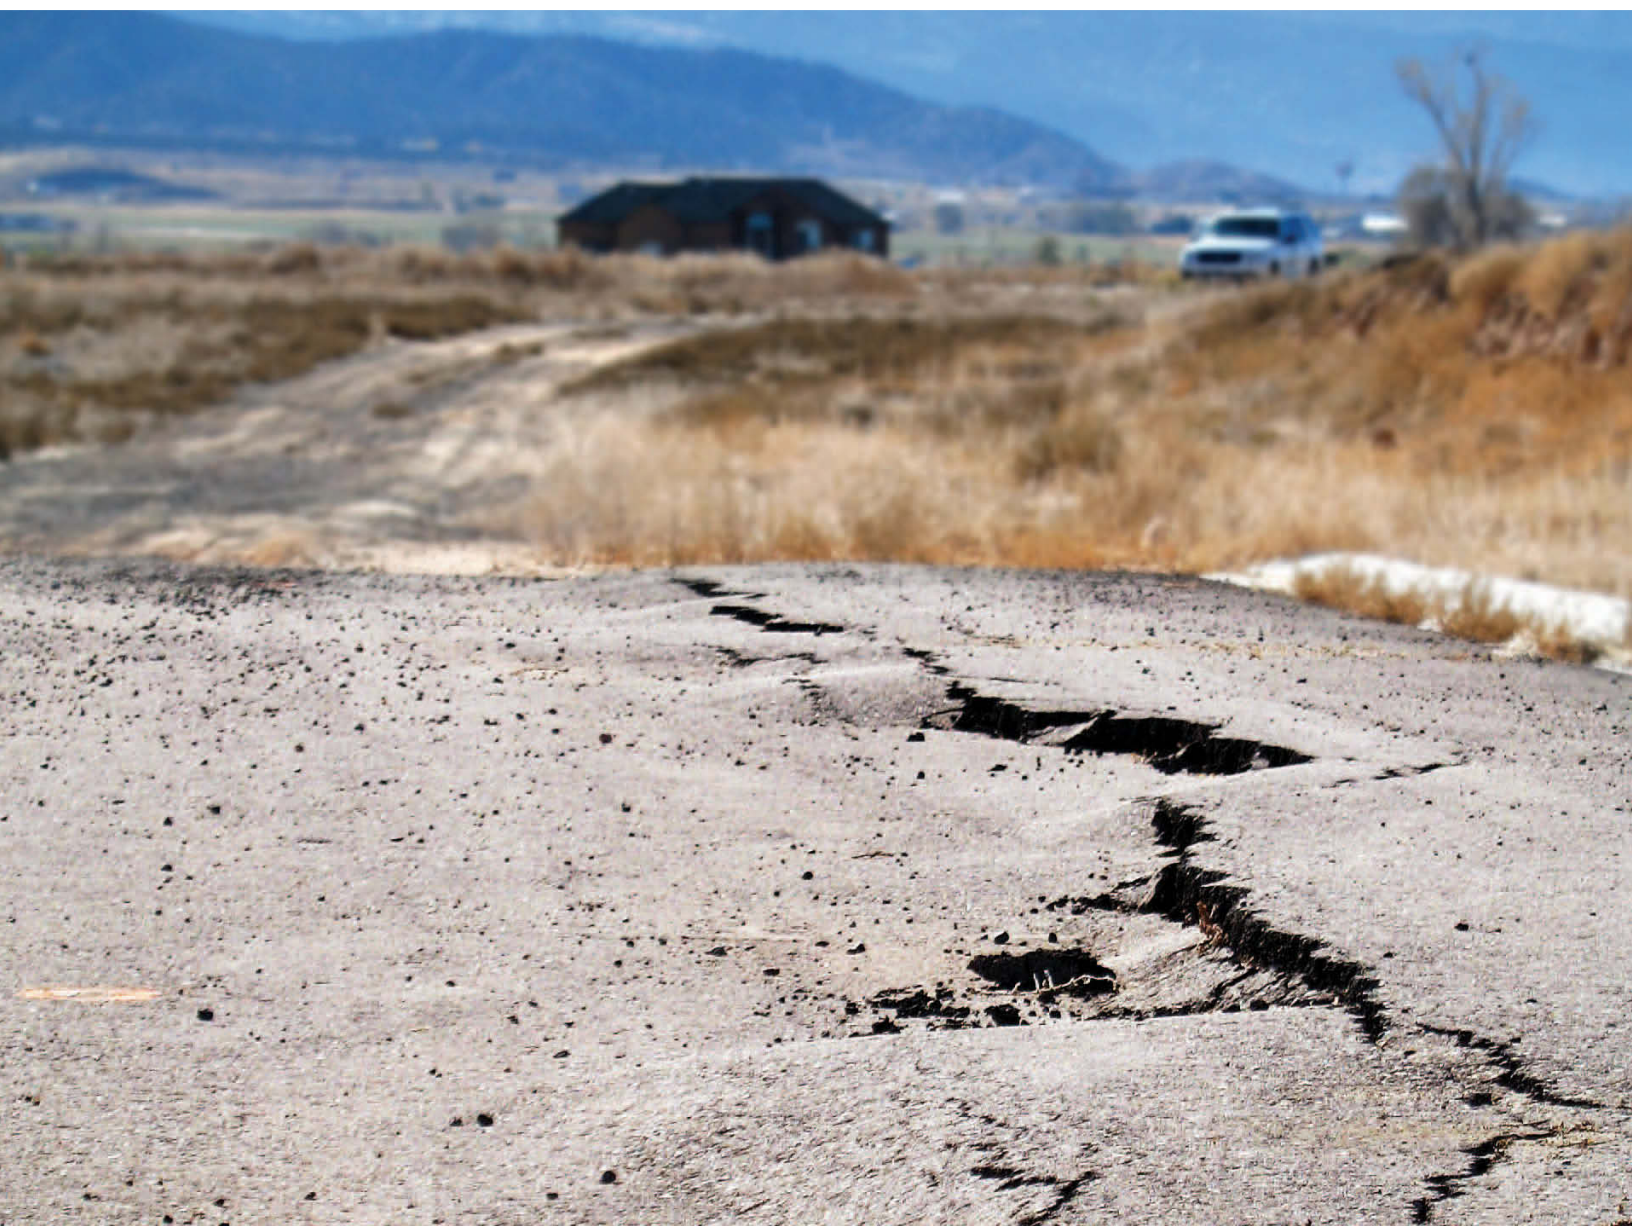
*Cover photo: The Enoch-graben-west fissure, EGWF1,
displaces pavement that is less than three years old in Enoch City's Parkview subdivision.
Photograph taken on November 3, 2009; view is to the south.*

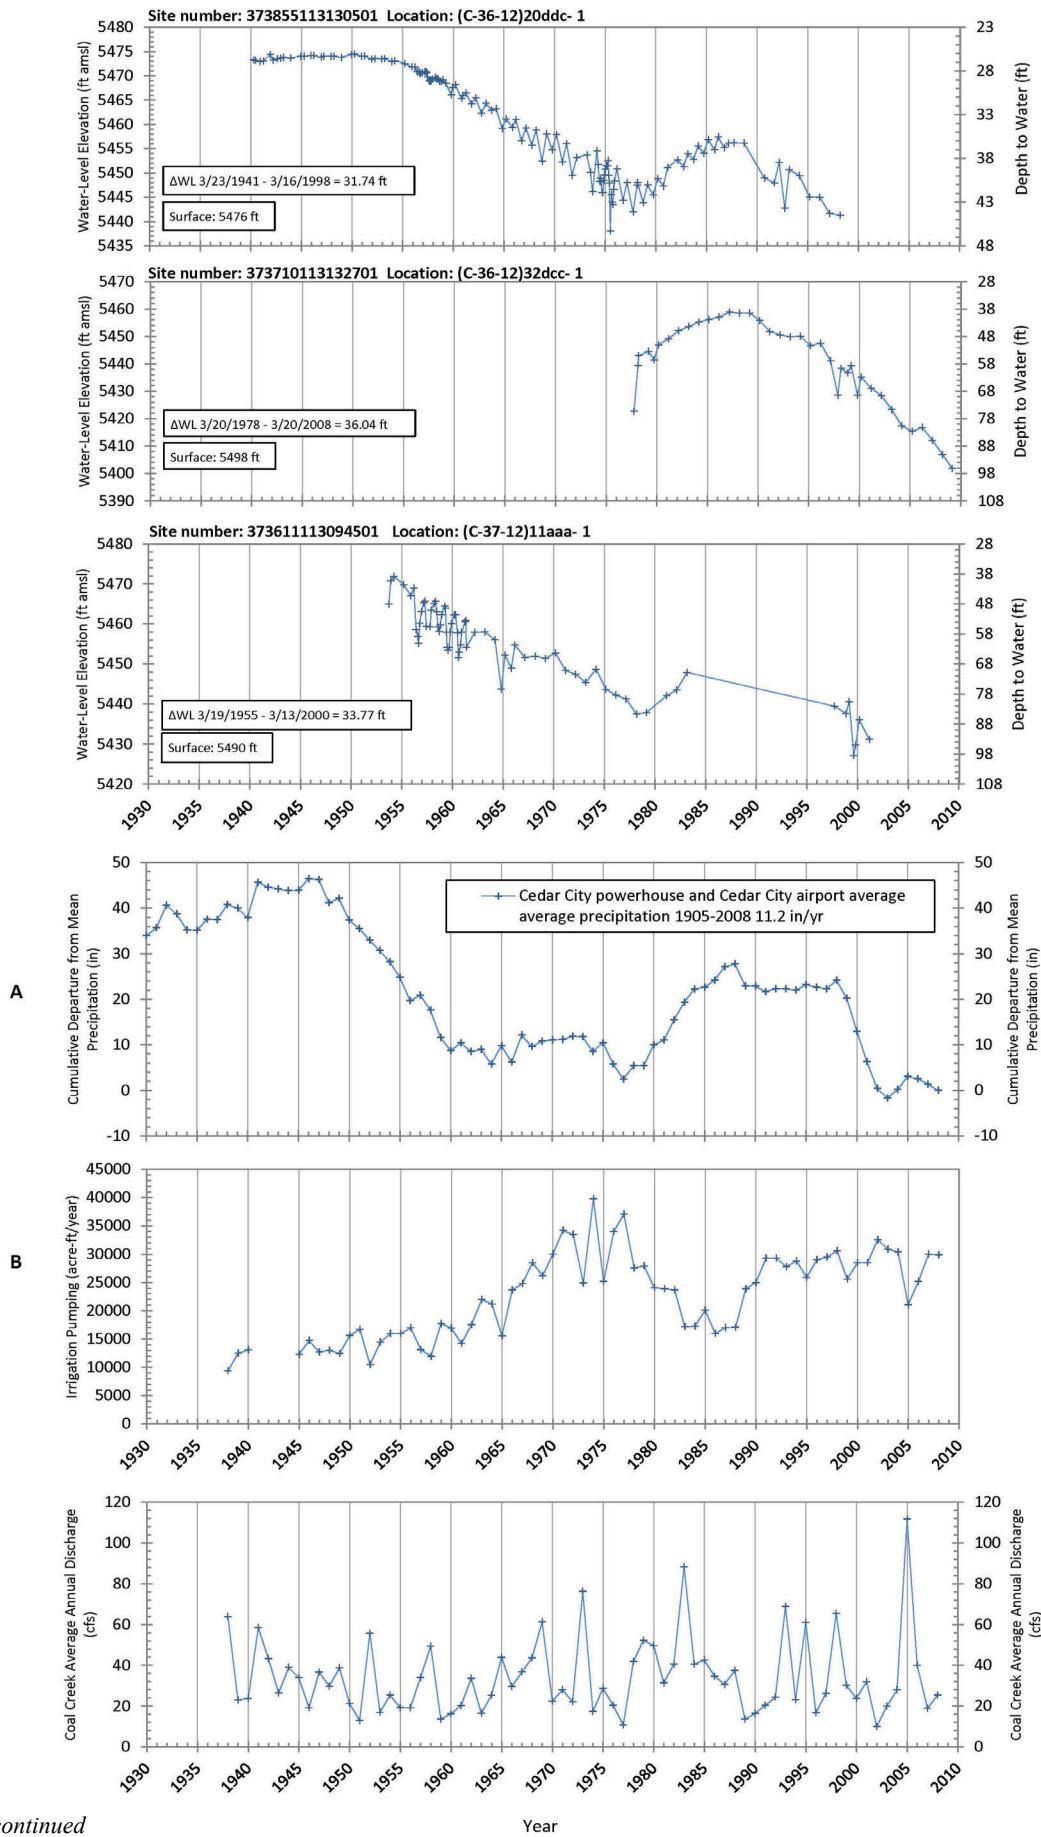
Figure 17. Hydrographs from selected NWIS (U.S. Geological Survey, 2010) wells. Well locations are shown on figure 18.

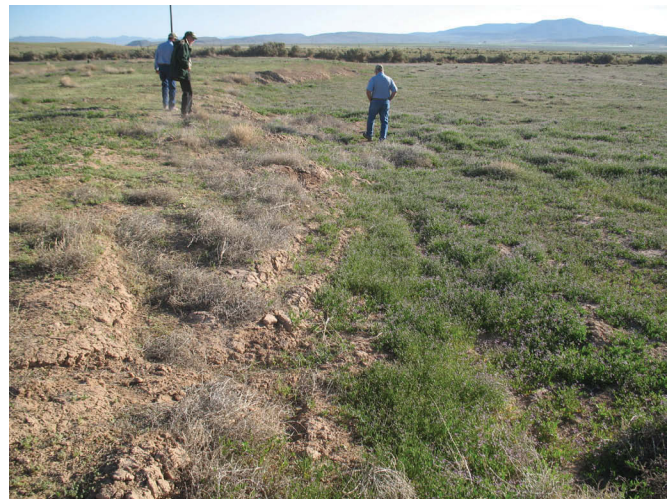
Figure 24. Scarp produced by down-to-the-east displacement across the EGWF1 fissure immediately north of the Parkview subdivision in Enoch City (view is to the northeast). Photo taken in May 2009.

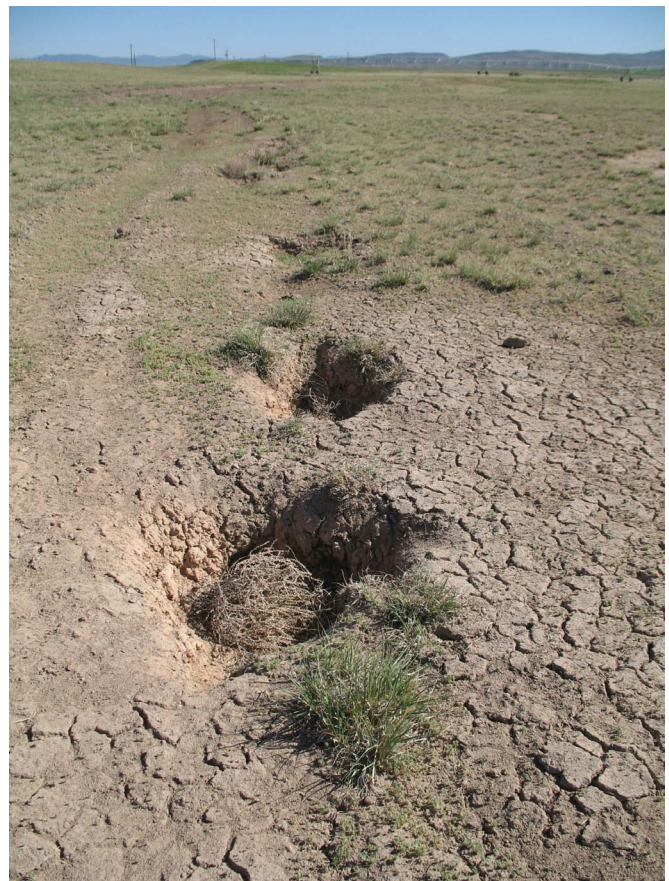
Figure 25. Sinkholes aligned along the EGWF1 fissure (view is to the northwest). Photo taken in May 2009.

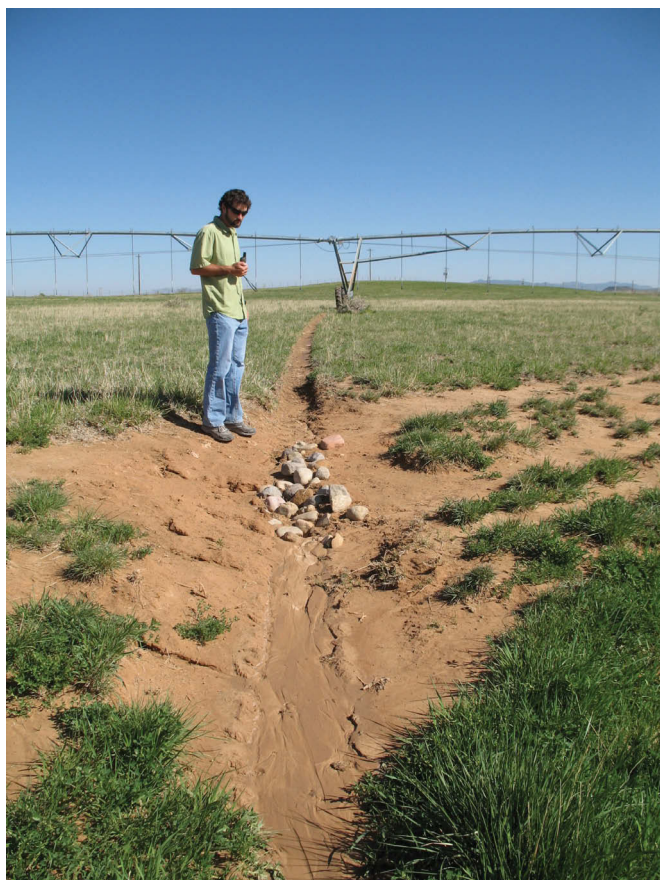
Figure 28. Repair to irrigation pivot track where it crosses the scarp of the EGWF1 fissure (view is to the northwest). Photo taken in May 2009.

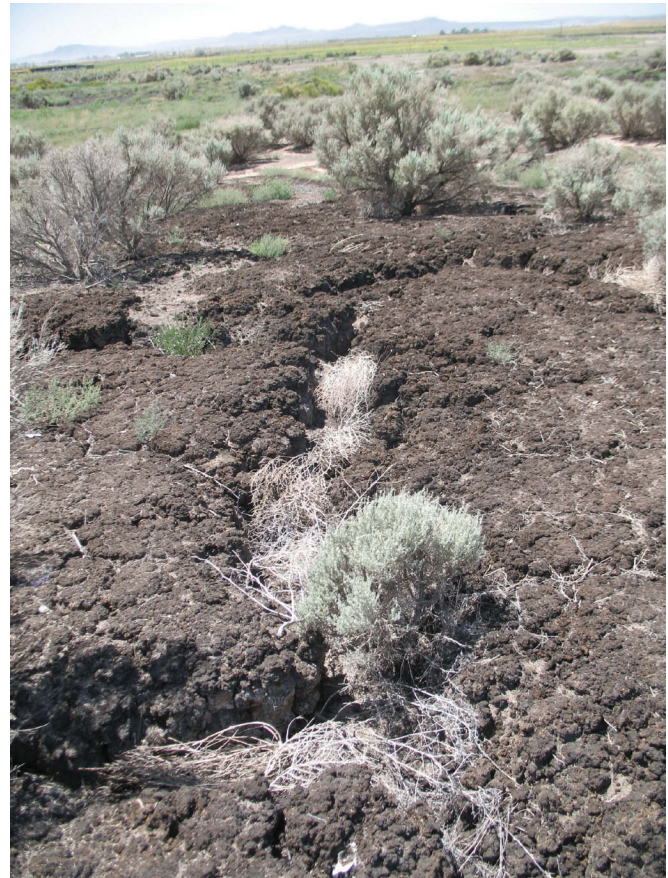
Figure 37. Vertical desiccation cracks developed in dried peat deposits on the east side of the Enoch graben in a former marsh area (view is to the northwest). Photo taken in June 2009.

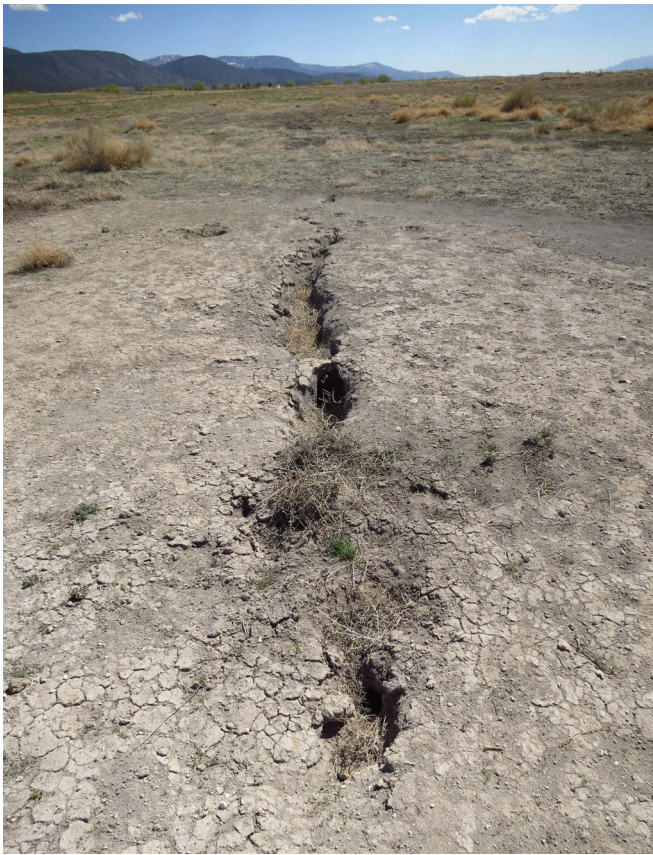
Figure 38. Trace of an EGEF5 fissure formed on fine-grained alluvial-fan deposits. View is to the south. Photo taken in April 2013.

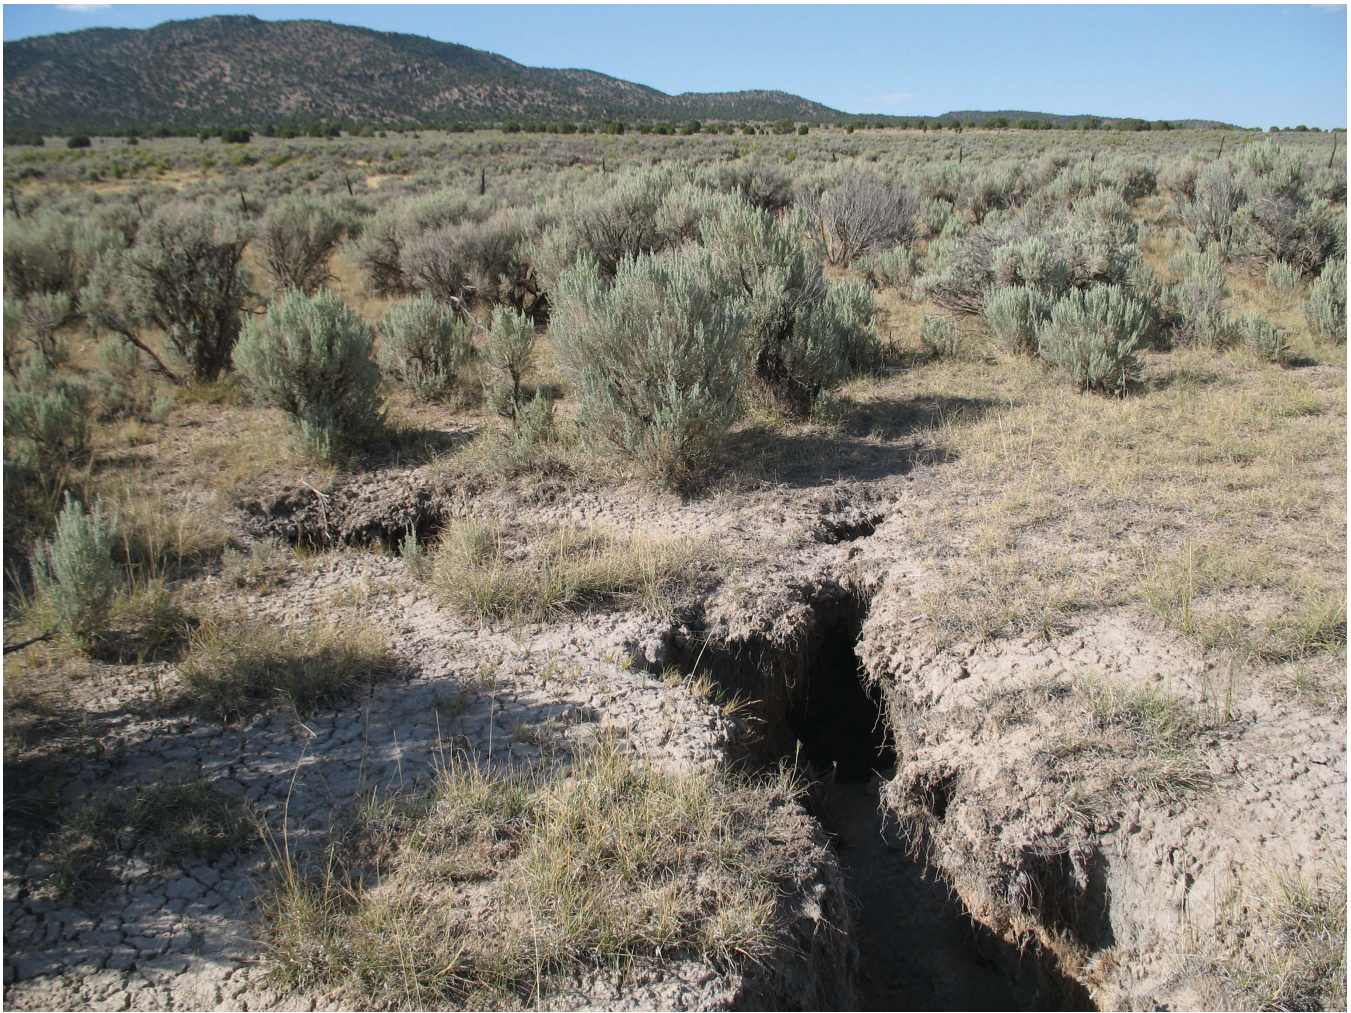
Figure 41. Vertical-walled gully eroded along a QNF1 fissure. Note branching pattern and soil bridging across the fissure (view is to the north). Photo taken in August 2009.

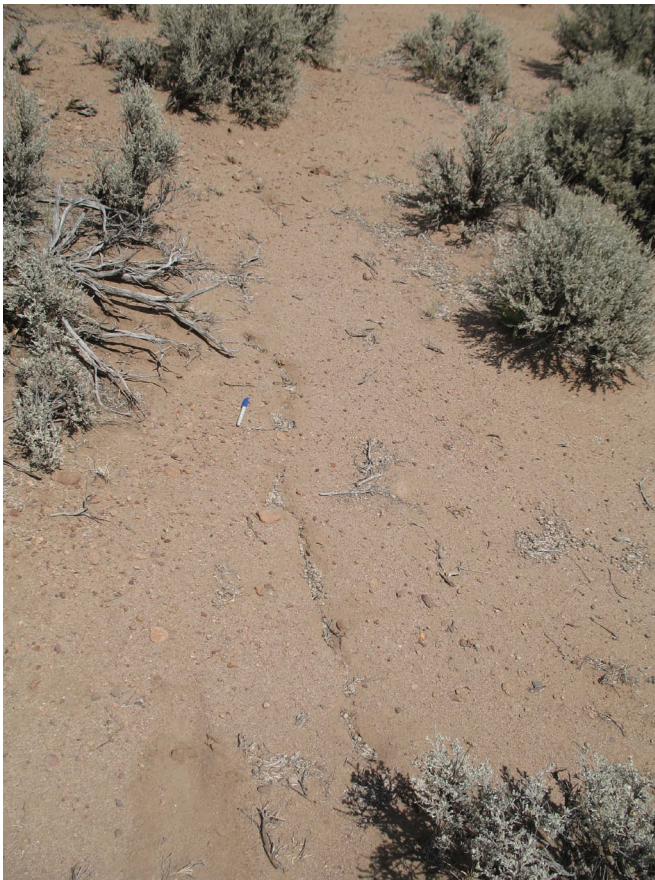
Figure 43. Fissure QWF1 expressed as an uneroded primary ground crack. This fissure could be traced for 900 feet before becoming obscured by recent agricultural activity. Photo taken in August 2009.

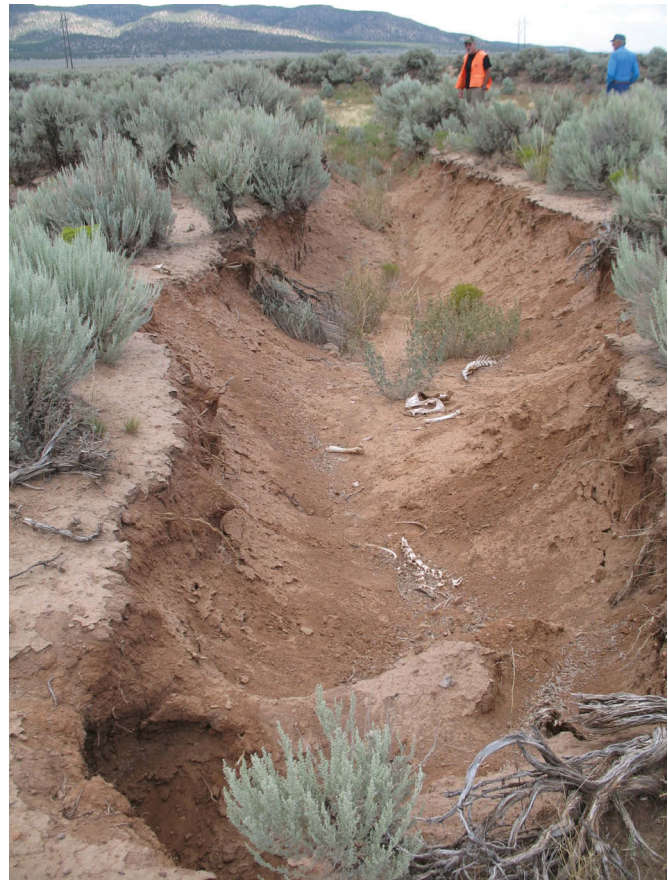
Figure 44. Gullied Quichapa-west fissure QWF4 where it crosses a stock pond (view is to the north). Photo taken in August 2009.

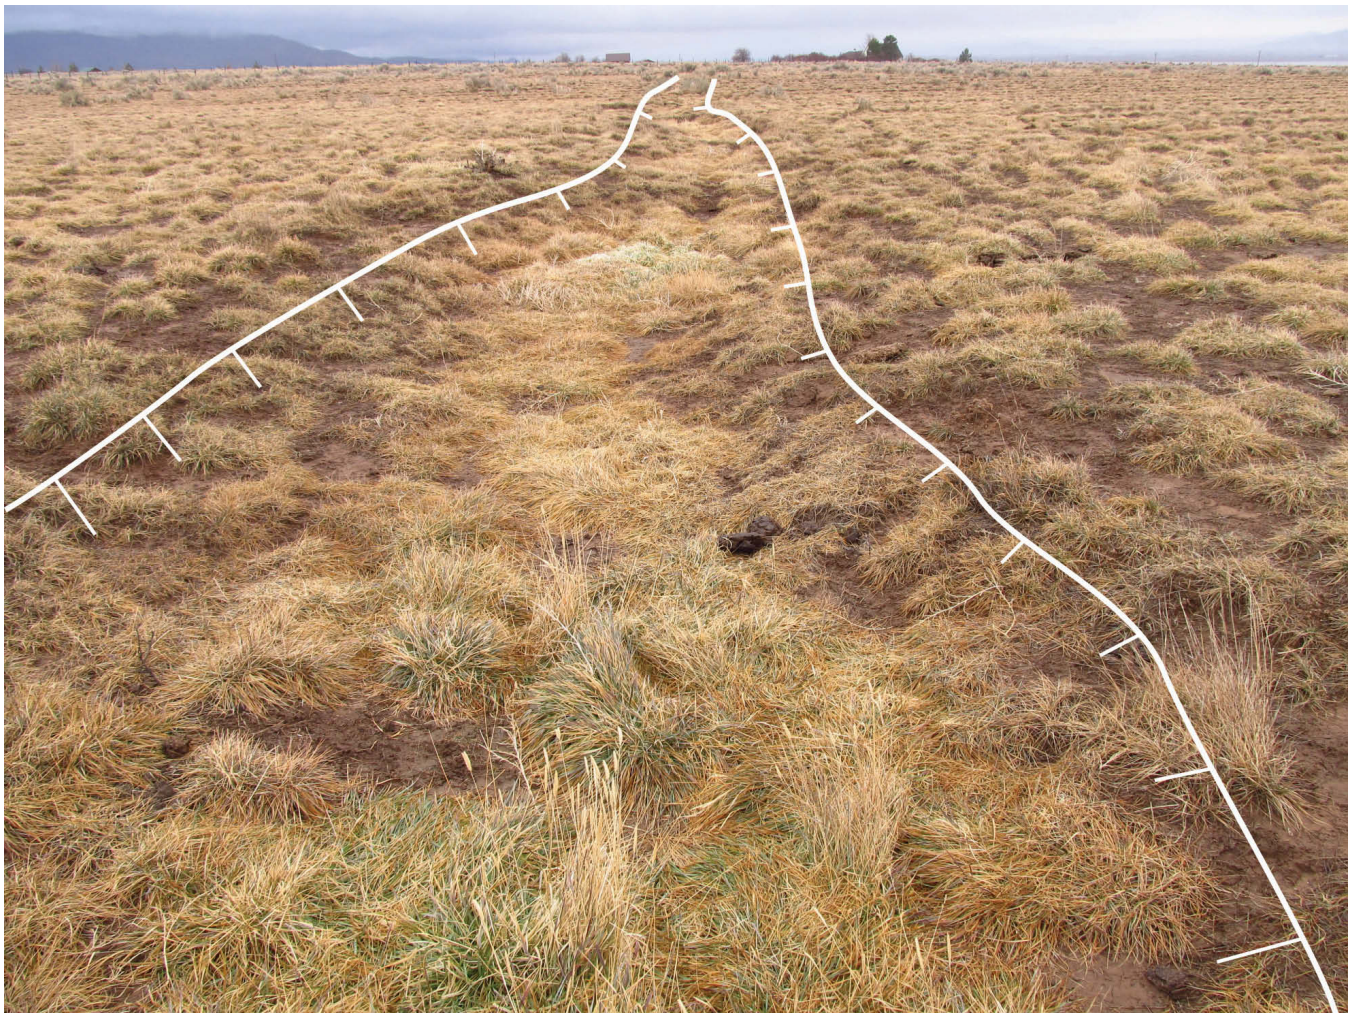
Figure 45. Linear depression 4 to 5 feet wide developed along the Quichapa-southwest fissure (view is to the north). Ticks point toward depression. Photo taken in December 2012.

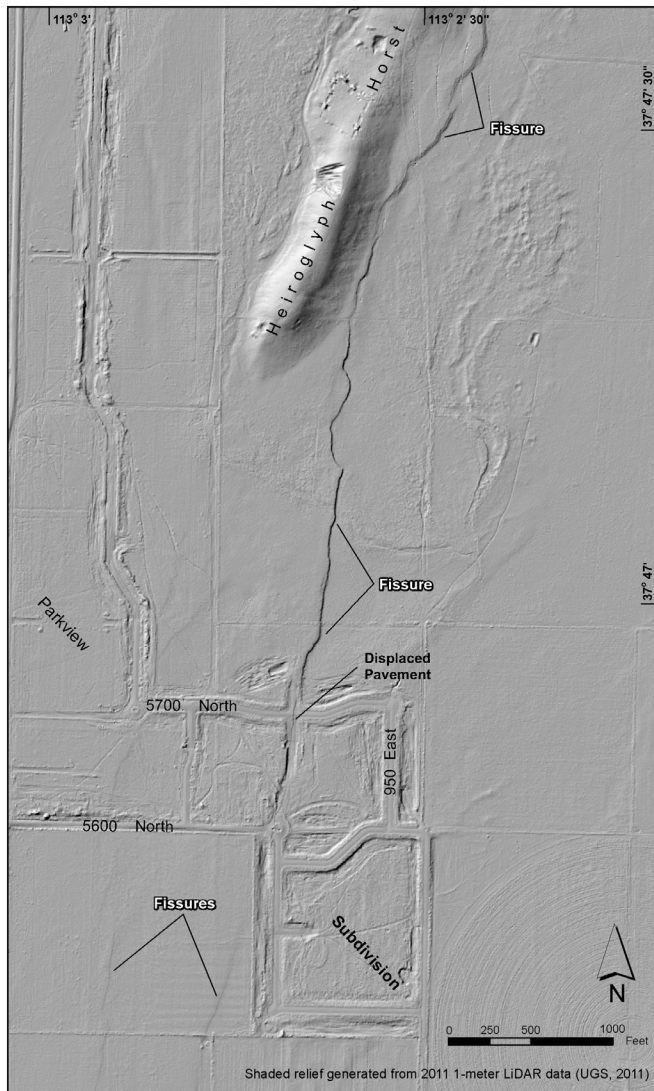
Figure 47. UGS (2011) bare-earth LiDAR image of the south end of the Enoch-graben-west fissures. These fissures exhibit vertical down-to-the-east displacement and are well expressed on LiDAR imagery.

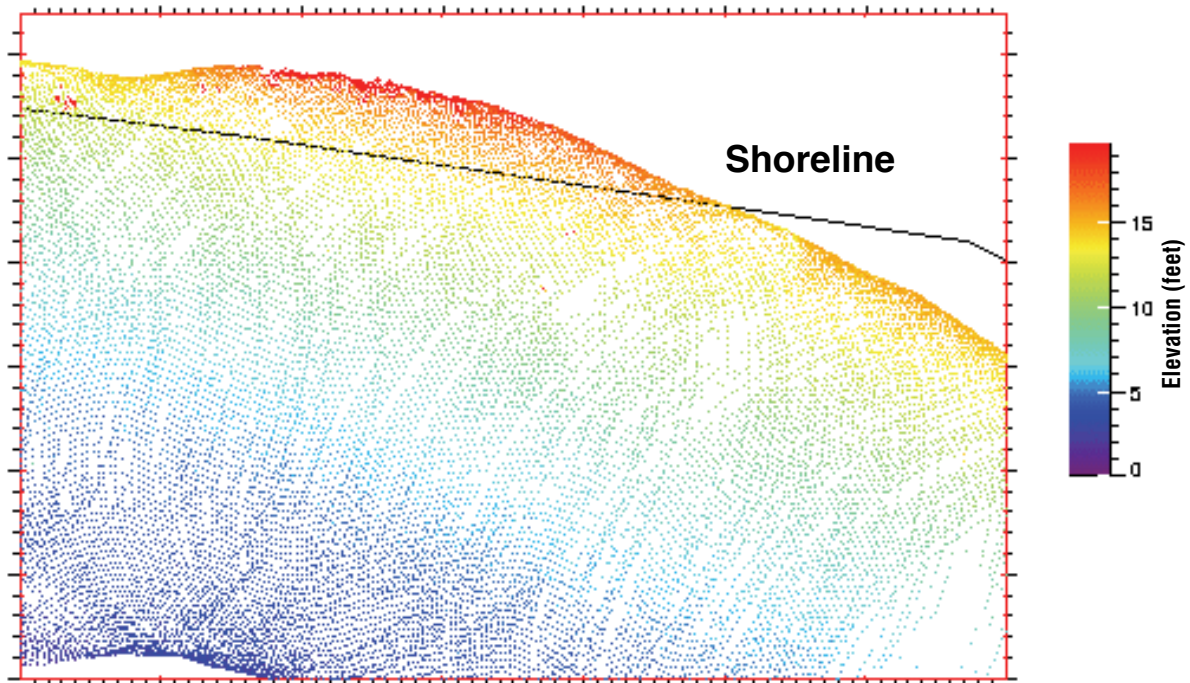
Figure G3. Scanning swath from the ATM-2 LiDAR scanner showing oscillating scanning motion (modified from National Oceanic and Atmospheric Administration, 2008). Individual laser data points are shown as colored points.
