SPECIAL STUDY 150: INVESTIGATION OF LAND SUBSIDENCE AND EARTH FISSURES IN CEDAR VALLEY, IRON COUNTY, UTAH

2014

Utah Geological Survey

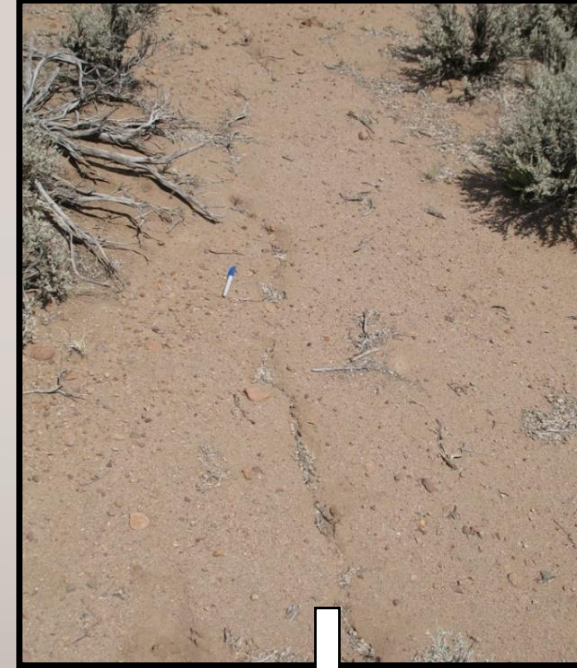
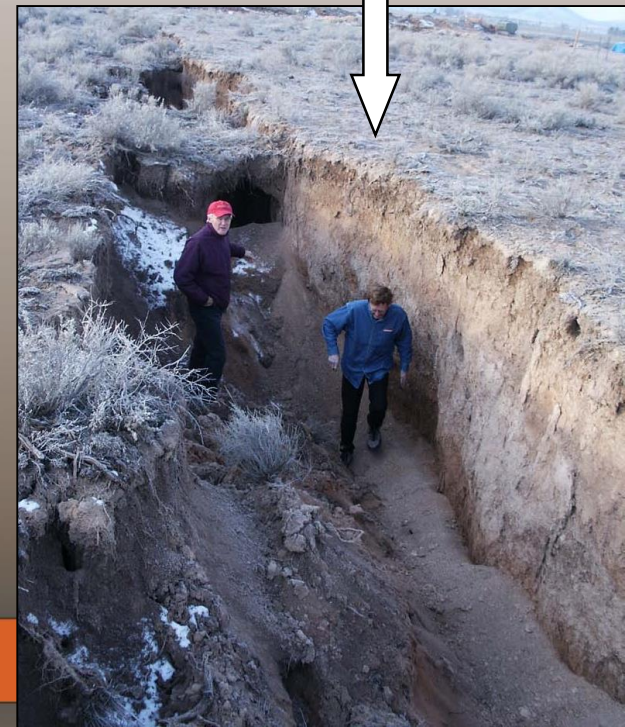
Earth Fissures

- Typically form as hairline cracks extending to water table
- Enlarged by surface-water erosion

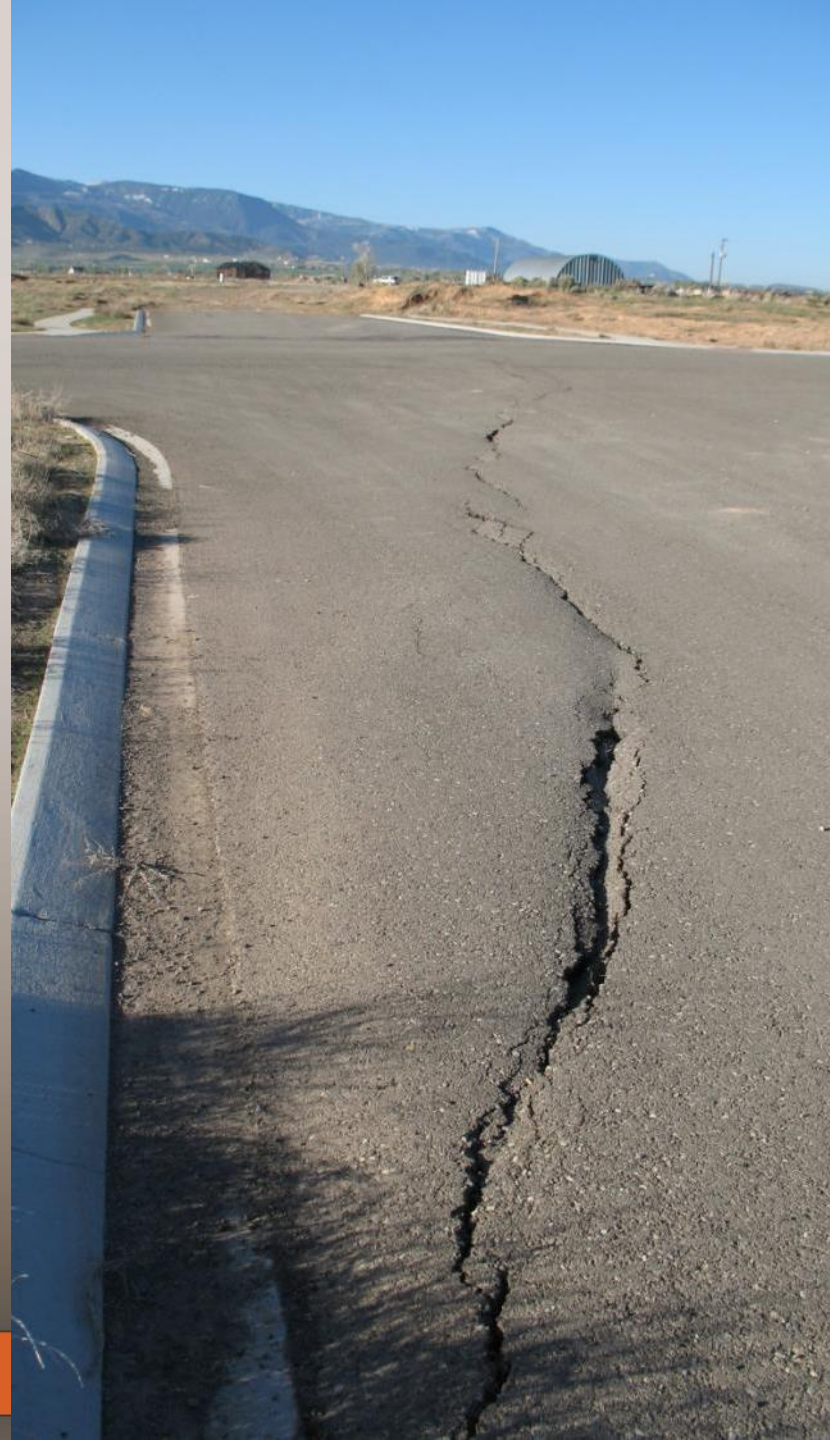
- May, 2009: Enoch City contacted the UGS to report a “fault” bisecting the new ~300-lot Parkview subdivision
- Cracked and displaced pavement/curbs, sewer line
- Nearly 2 ½ miles long fissure
- First subsidence/fissure to cause substantial damage to Utah’s built environment
 - Contracted with CICWCD to perform detailed study

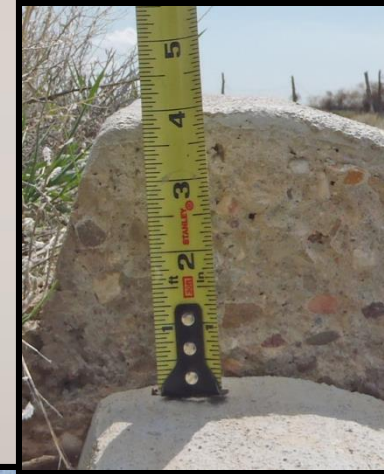
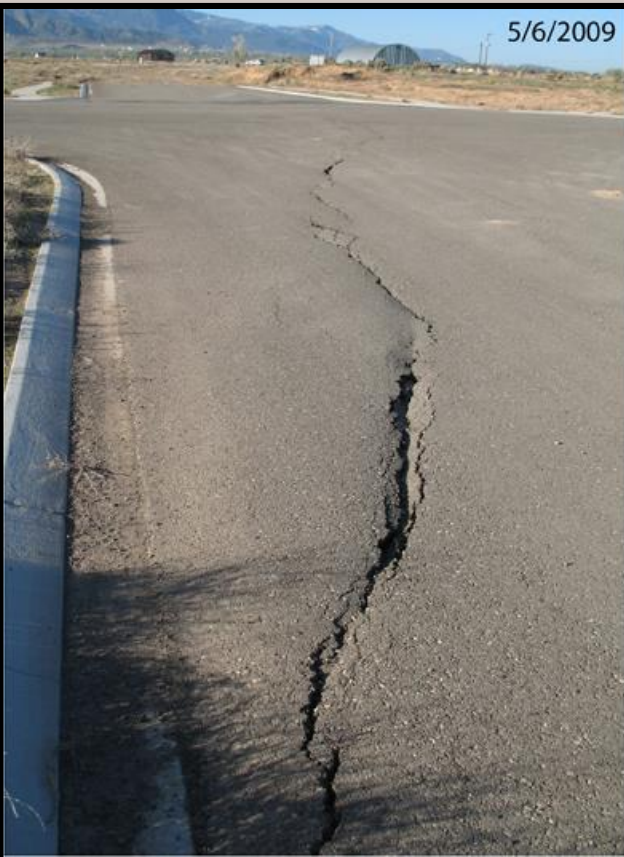
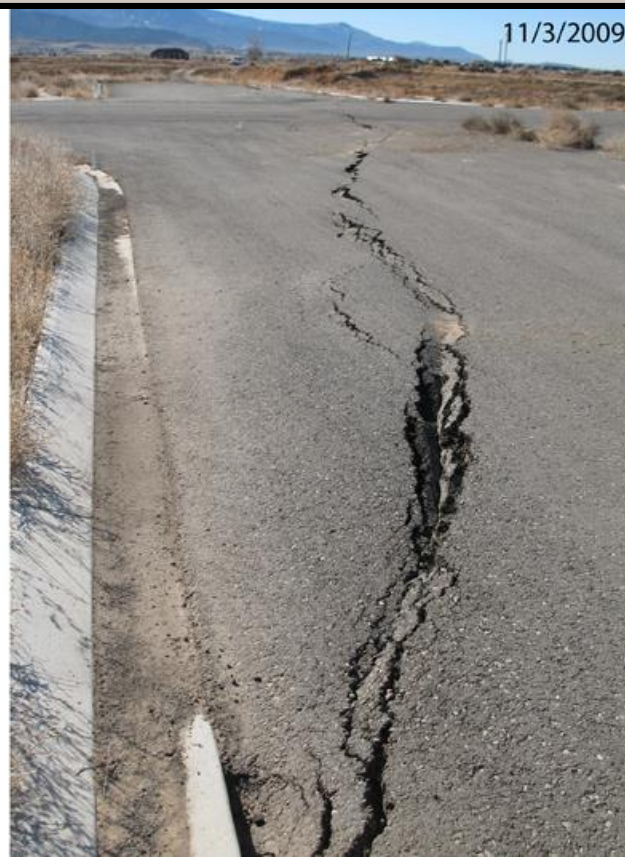
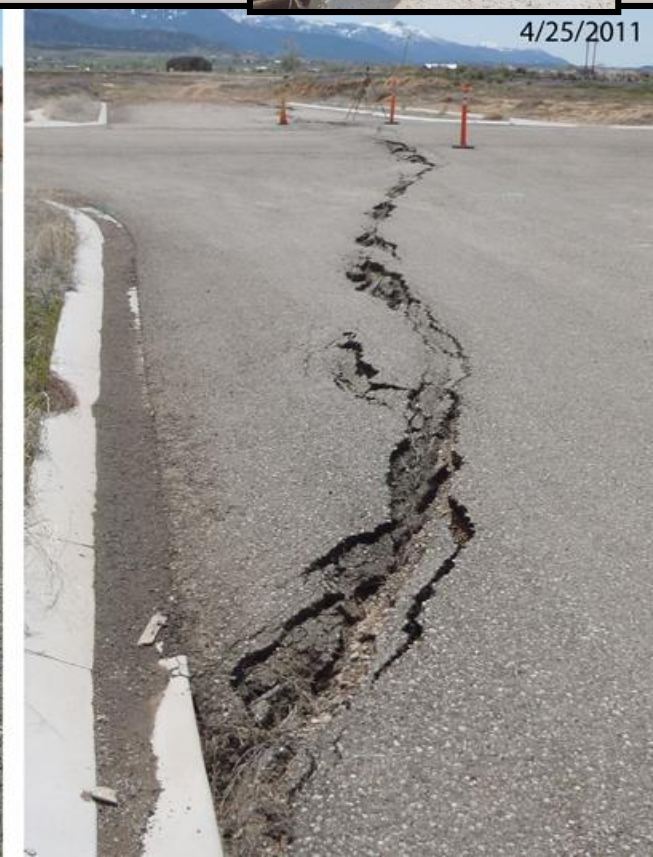
Fissure Continues to Grow

- Vertical displacement rate of the Enoch-graben-west fissure has been about 1.7 inches/year

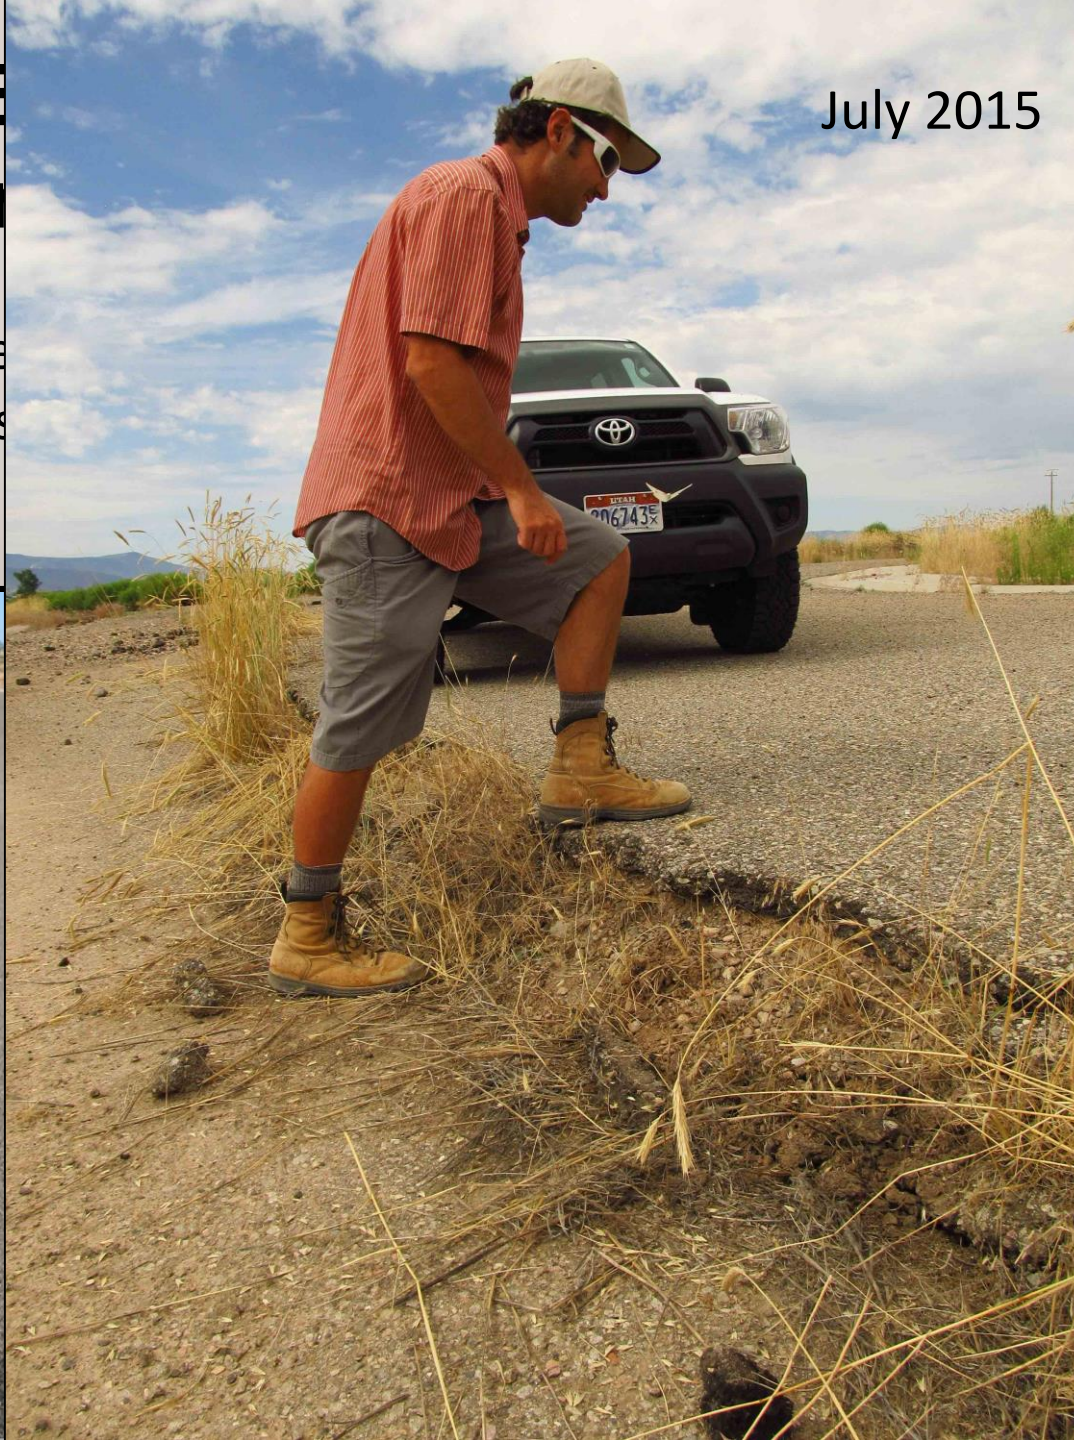
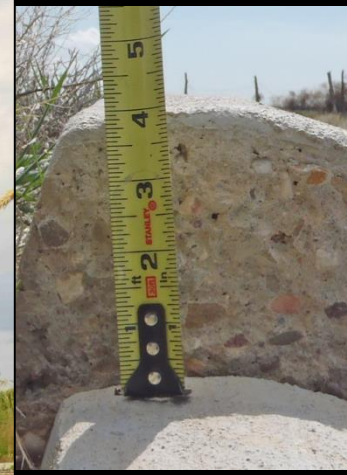
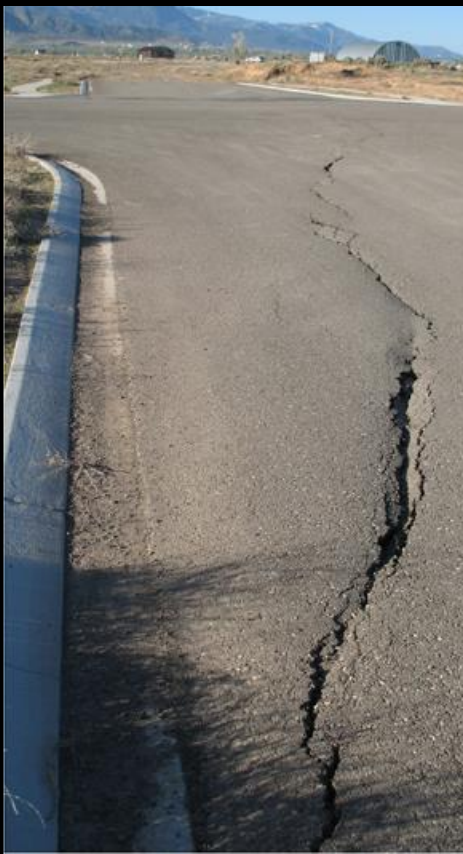
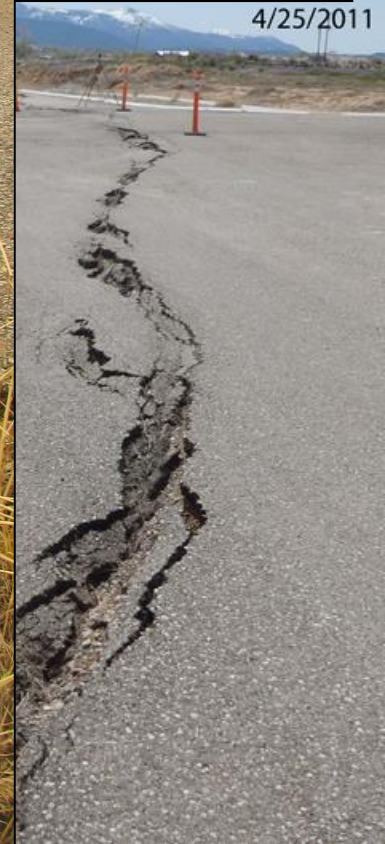
- Vertical displacement graben-west fissure inches/year

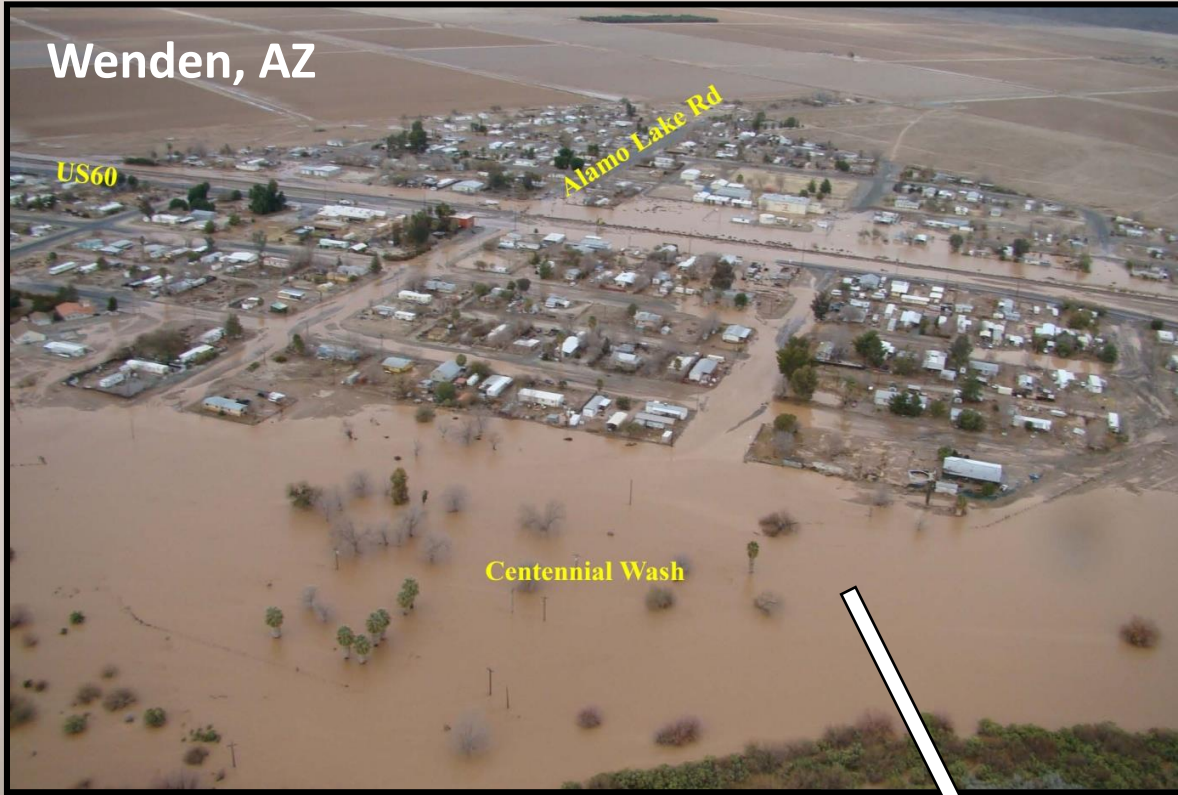
Wenden, AZ

- Change natural flood patterns
- January, 2010 flood in Wenden, SW Arizona
- InSAR reveals subsidence bowl near agricultural wells

InSAR = ~2 in / year

GPS = 2.7 ft since 1991

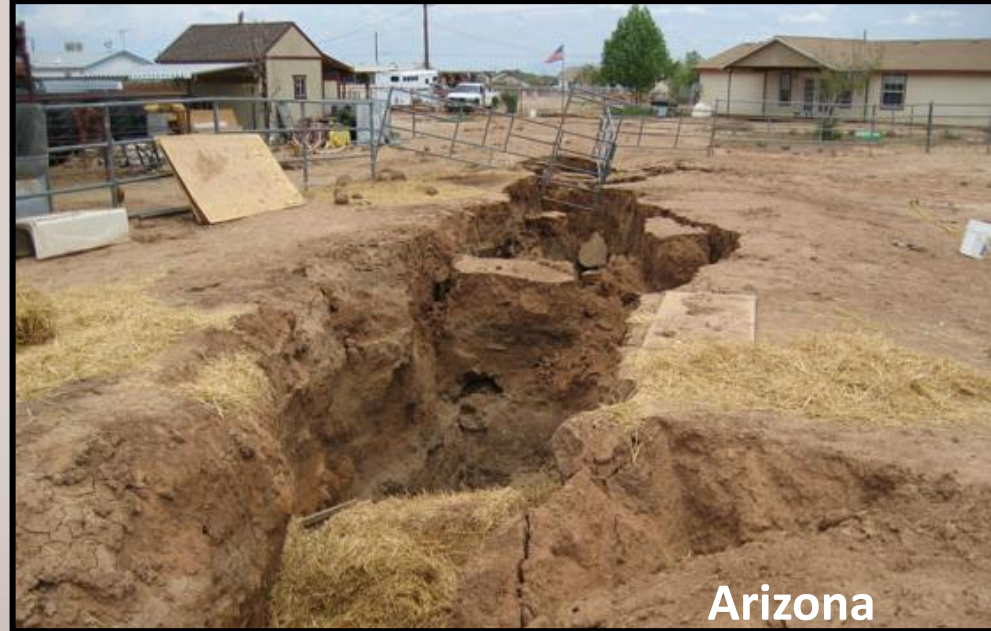
Arizona

- Undercut and damage infrastructure
- Can widen/deepen dramatically within hours
- **AZ:** hundreds of millions of dollars in damage to buildings, roadways, railroads, utilities, aqueducts, etc

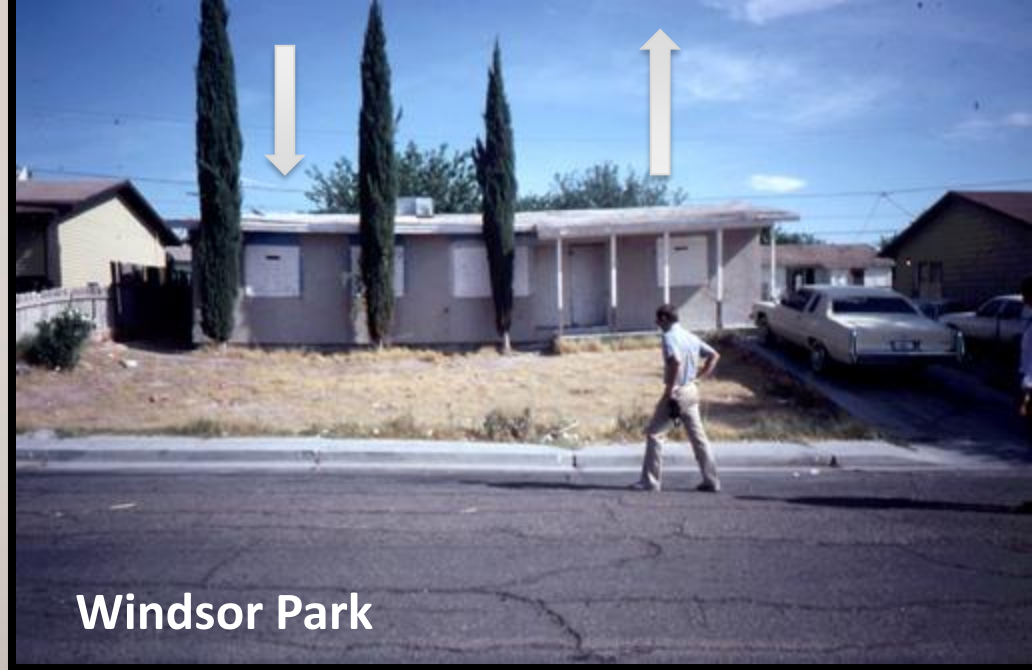
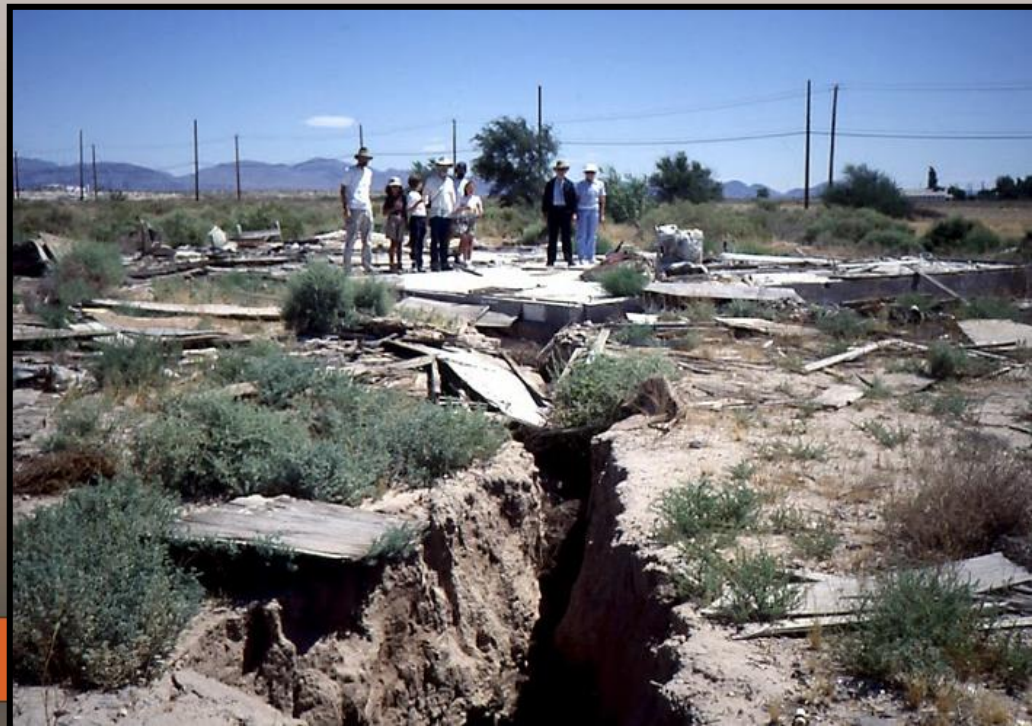
Fissure Hazards

- **Nevada:** 135 homes abandoned and removed in Windsor Park subdivision in North Las Vegas in early 1990s (cost= \sim \$20 million)

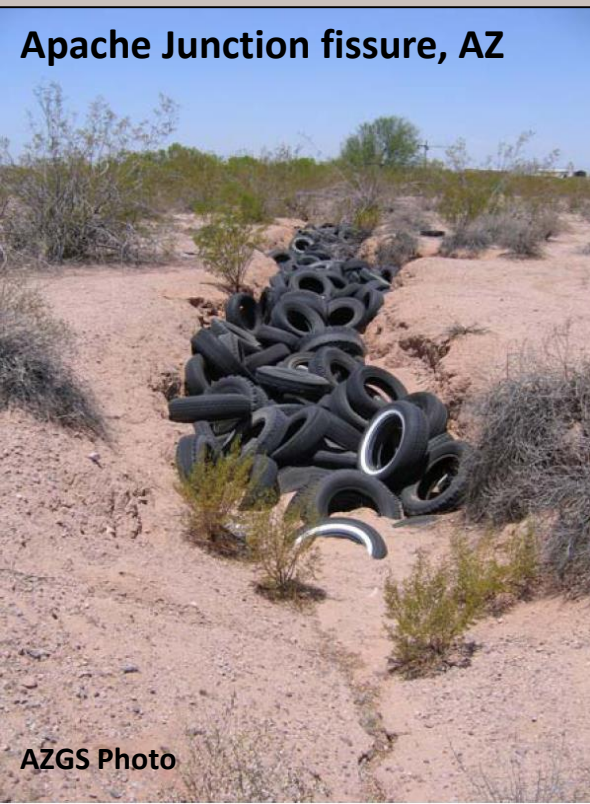
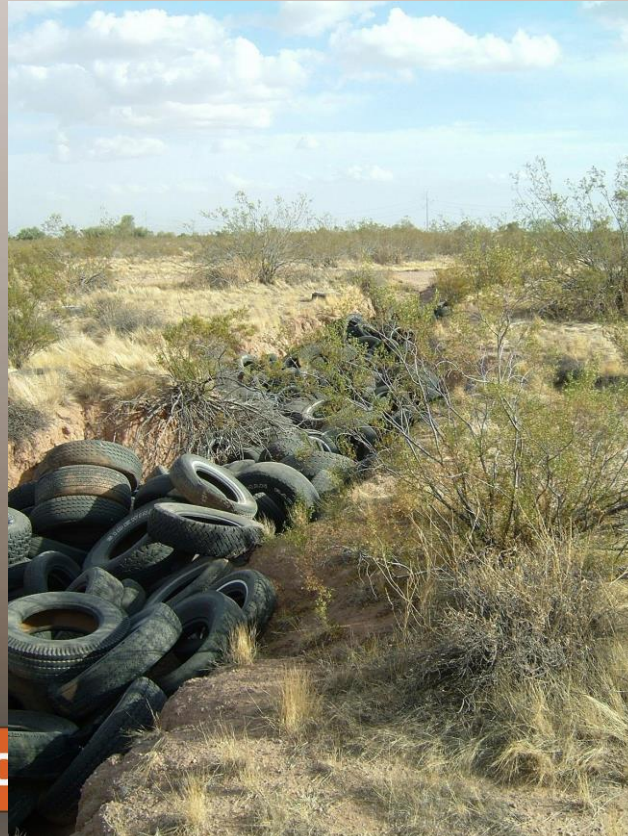
AZ

- Can provide direct conduits for contaminated surface water to reach aquifers
- AGS: refrigerators, pharmaceuticals, tires, manure, garbage, dead animals, 55-gallon barrels of ?
