GEOTECHNICAL INVESTIGATION REPORT

Cedar Highlands Water Tank – Site 2

Landmark Project No: 220353

Subject: Geotechnical Investigation Report
Cedar Highlands Water Tank – Site 2
Iron County, Utah
Landmark Project No.: 220353

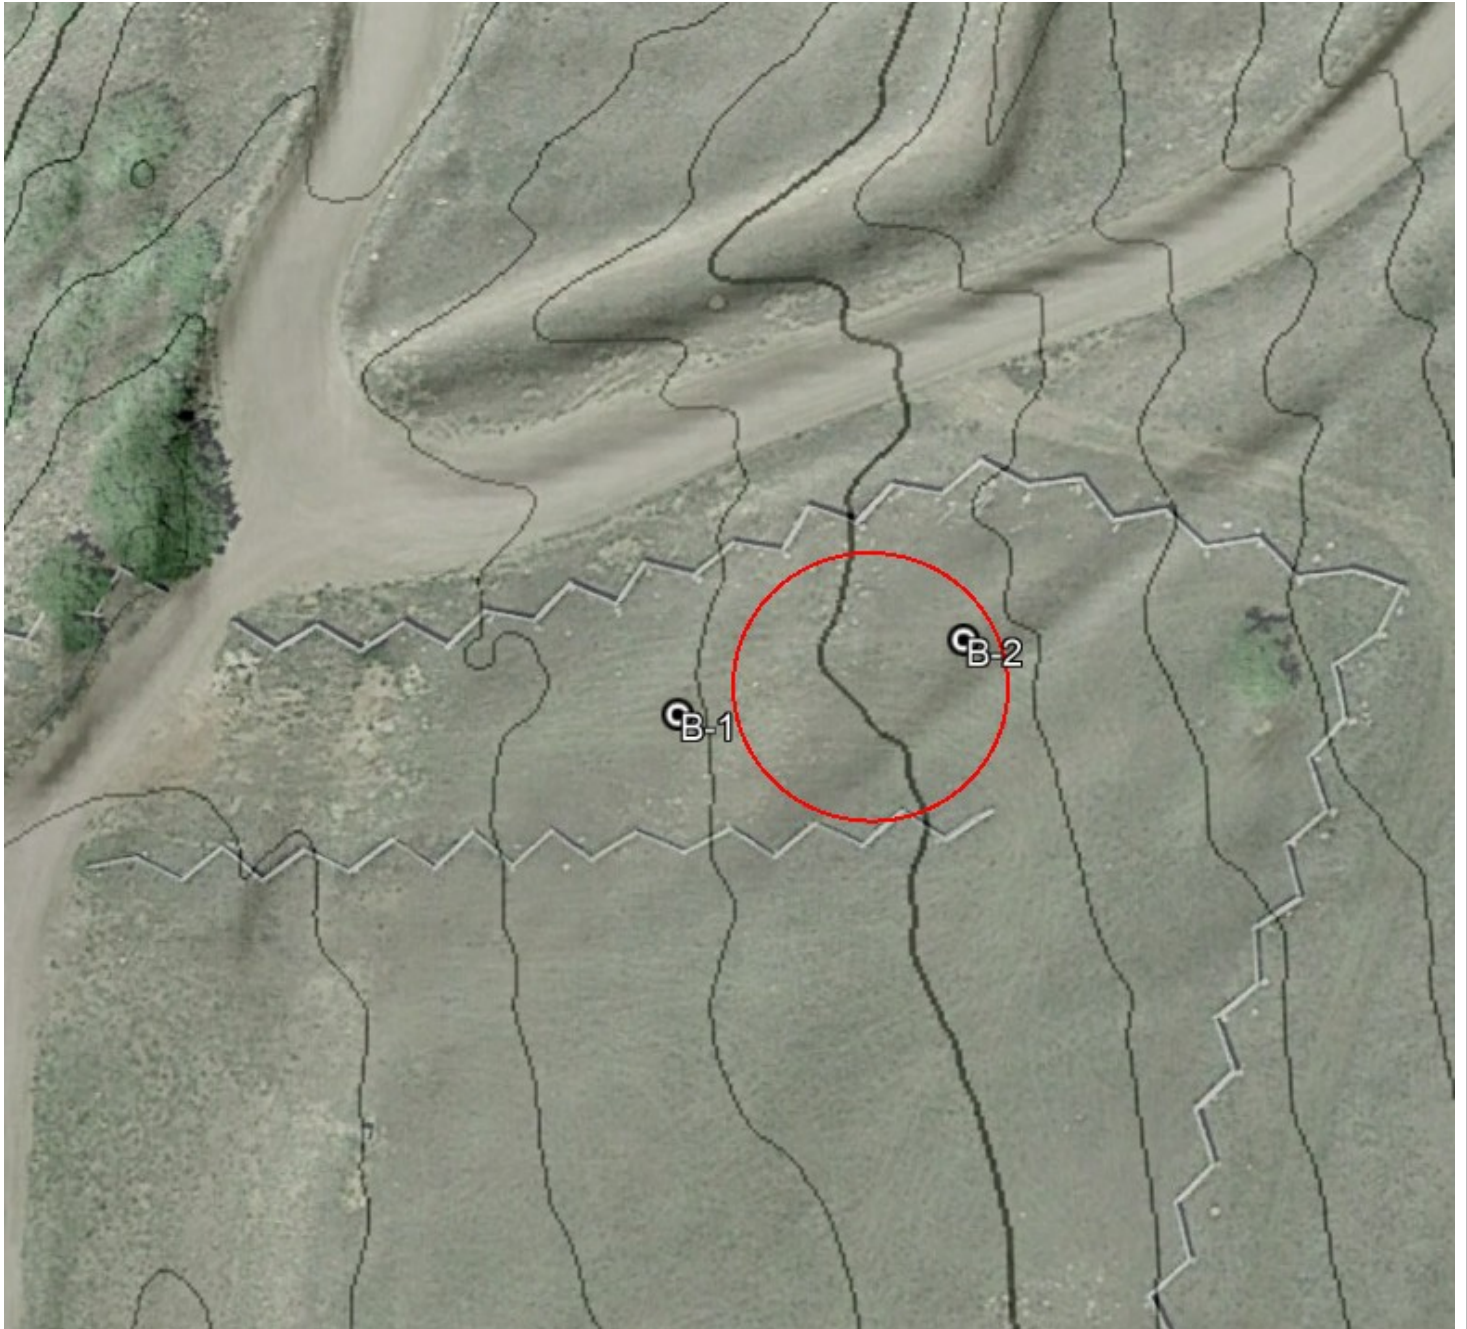
Figure A-2

Site Map
Landmark Project No 220353

Two (2) borings were completed to a maximum depth of 50.0 feet within the anticipated tank site footprint in order to characterize subsurface conditions at the site for the structure. The borings were drilled with a CME 55 drill rig utilizing 8.0-inch O.D. hollow-stem augers. Samples were obtained with a 3.0- inch O.D., split barrel, sampler driven with a 140-lb auto hammer dropping 30 inches. Depending on subsurface conditions, bag or block samples of soil were obtained from the borings. When bedrock was encountered, the upper 10 feet of the bedrock was cored with an HX core barrel. A Landmark geologist, Mr. Greg Kaiser, supervised drilling and sampling operations. Approximate boring locations are shown on Figure A-2.

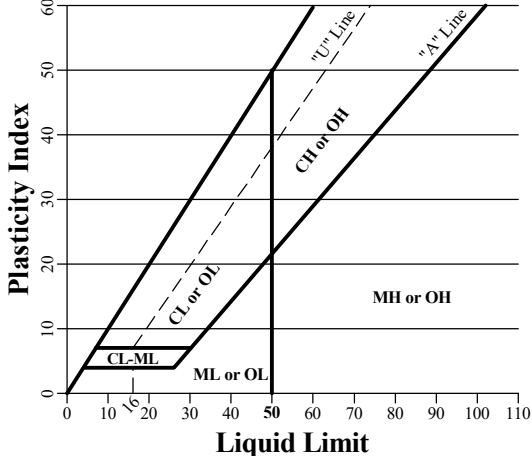
CLASSIFICATION		Range of Grain Size																																												
	U.S. Standard Sieve Size	Grain Size in Millimeters																																												
BOULDERS	Above 12"	Above 305																																												
COBBLES	12" to 3"	305 to 76.2																																												
GRAVEL	3" to No. 4	76.2 to 4.76																																												
	Coarse 3" to 3/4"	76.2 to 19.1																																												
Fine 3/4" to No. 4	19.1 to 4.76																																													
SAND	No. 4 to No. 200	4.76 to 0.074																																												
	Coarse No. 4 to No. 10	4.76 to 2.00																																												
	Medium No. 10 to No. 40	2.00 to 0.42																																												
	Fine No. 40 to No. 200	0.420 to 0.074																																												
SILT & CLAY	Below No. 200	Below 0.074

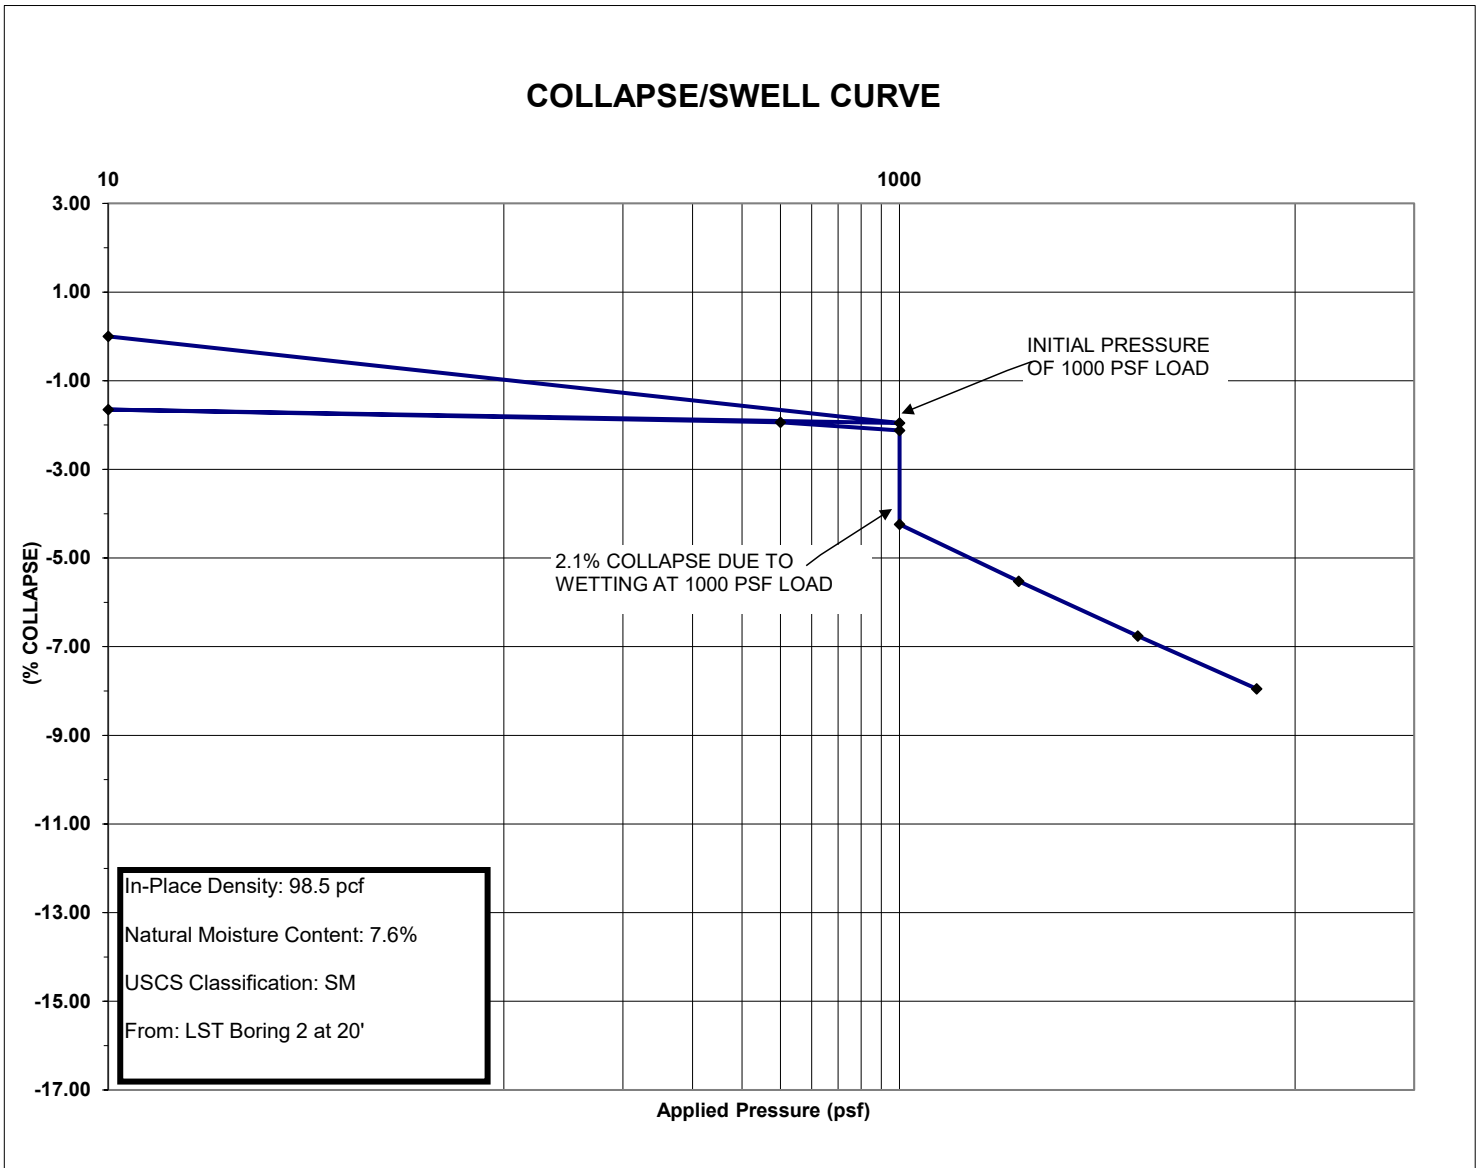
FIGURE B-4

CONSOLIDATION REPORT

Location of Sample: LST Boring 2 at 20'

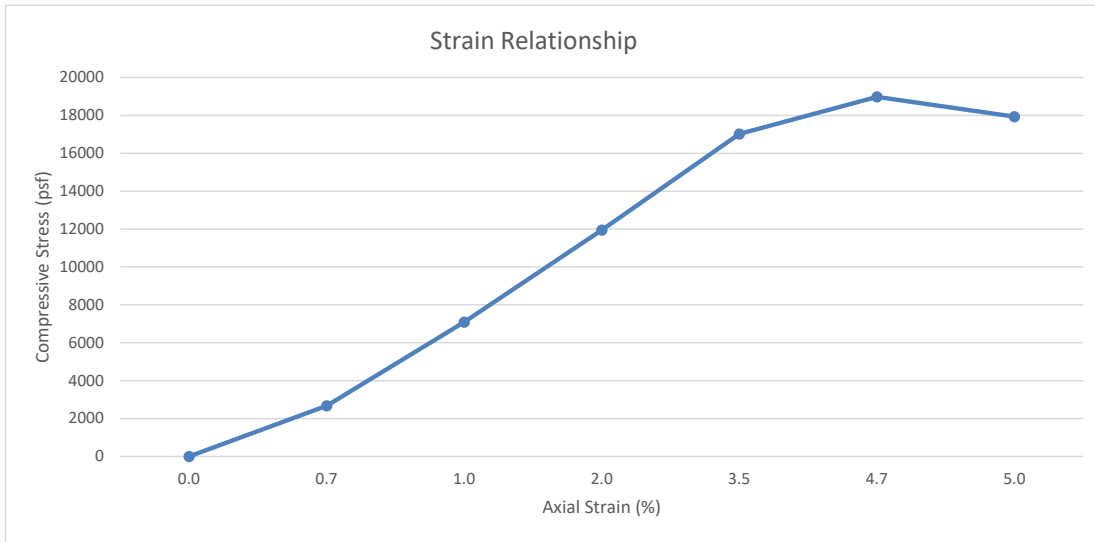
Unconfined Compressive Strength

Result
Initial Moisture %	11.2
Unconfined Compressive Strength (PSF)	18978.3
Average Height of Specimen (in)	3.85
Diameter of Specimen (in)	1.88
Height to Diameter Ratio	2.048
Average Rate of Strain to Failure, %	0.77
Strain at Failure (.001 in)	0.182
Type of Specimen	Intact
